**Alger Street
/Golfridge Drive
Ravine**

Bank Stability Study

City of Grand Rapids

HRC Project No. 20161027

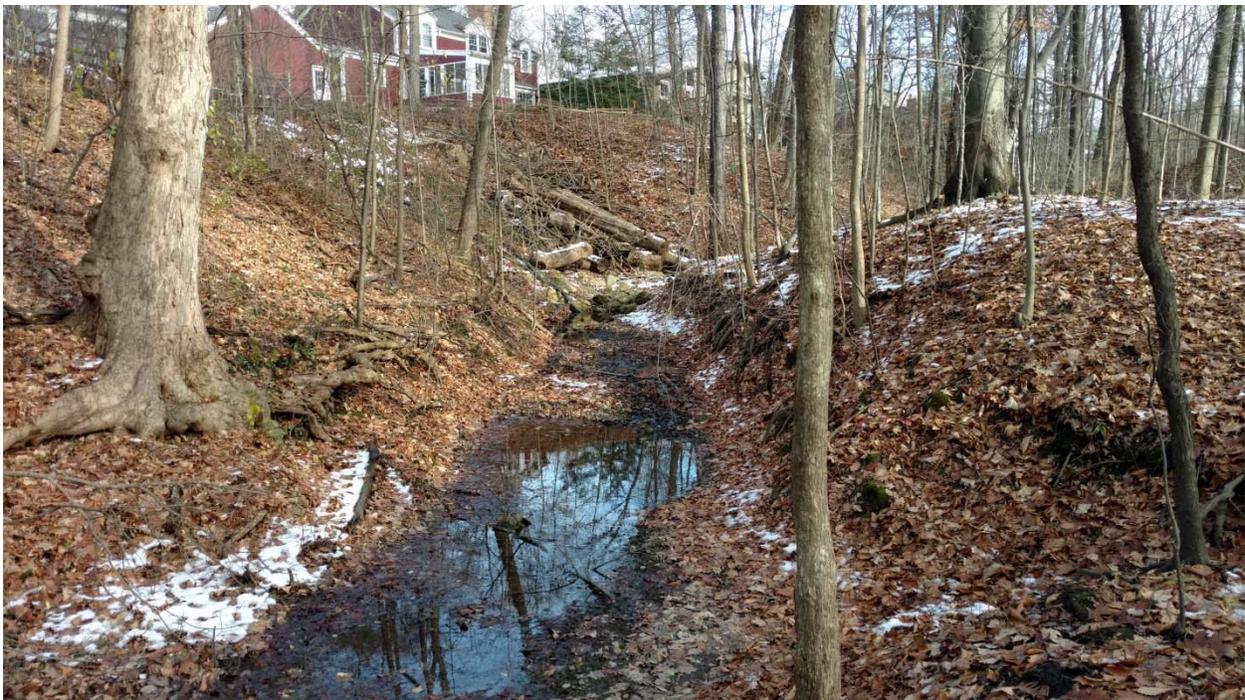
Figure 2 - Typical Alger Street Ravine Drainage Channel

Figure 2 indicates what was typically observed throughout most of the study reach. The width of the active channel represented in this photo measured out to be approximately 9.5 feet. It was very difficult to determine what the bankfull channel is in this reach due to the lack of geomorphic features that could be measured. This suggests that the water forces and flow rates that created the channel are likely sediment starved.

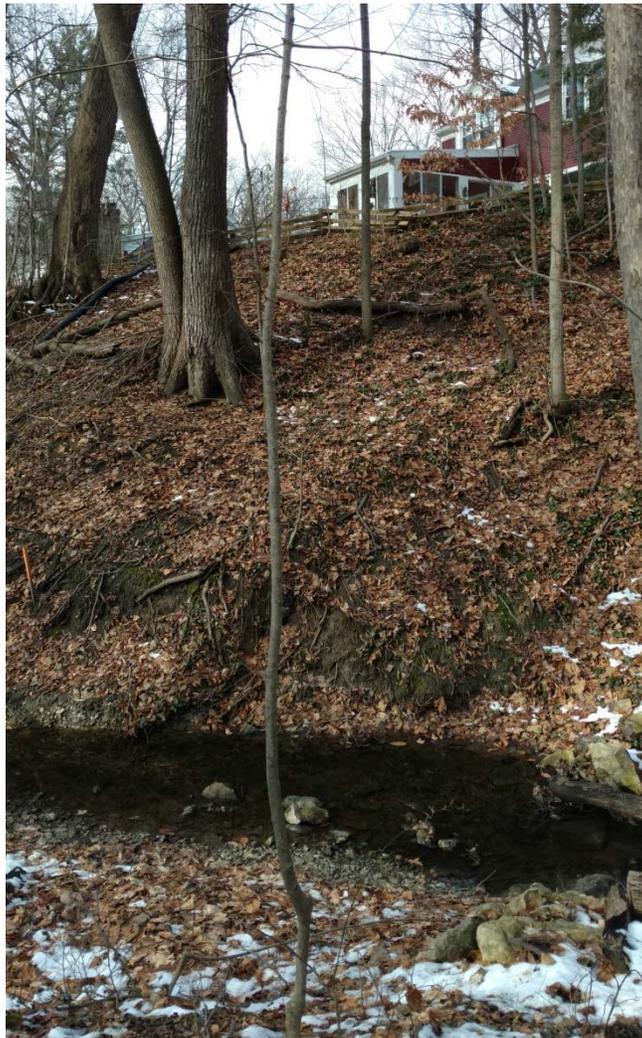
Figure 3 – Eroding Area behind the homes on Alger St.

- Four homes that are immediately downstream of the 21-inch storm sewer outlet on the right bank are affected by bank erosion or failure due to stream bank erosion issues. Figure 3 is a typical picture of an actively eroding area that was observed.

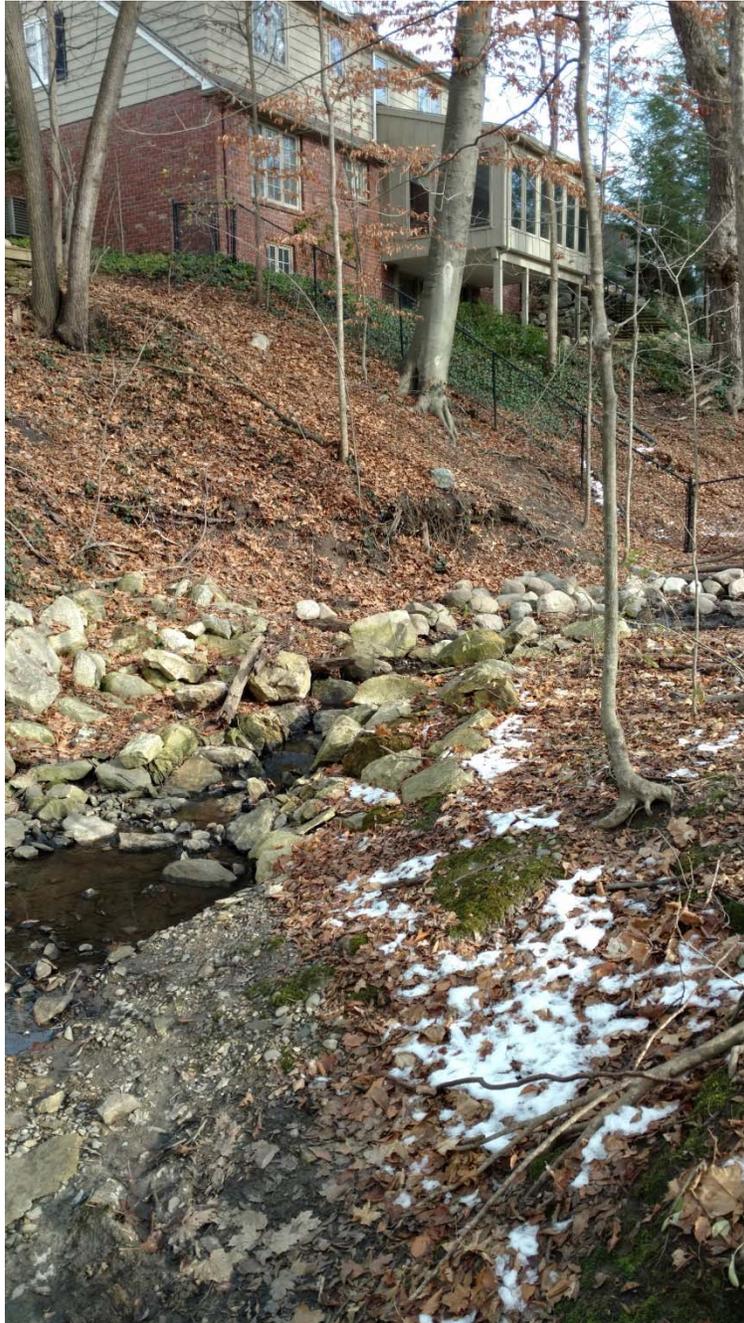
Figure 4 – Stream banks and bed stabilized by heavy boulder installation

The bank sections that were observed to be eroding are generally short in length and the sediment contributions from those reaches are very low. The sediment within the bottom of the channel appears to be relatively mobile. Due to the age of the sediment and the fact that the channel is over widened suggests that the stream does not have adequate sediment which, if available, would form a much narrower baseflow bankfull channel. Boulders appear to have been placed in areas to reduce storm discharge velocities as is shown on Figure 4 below.

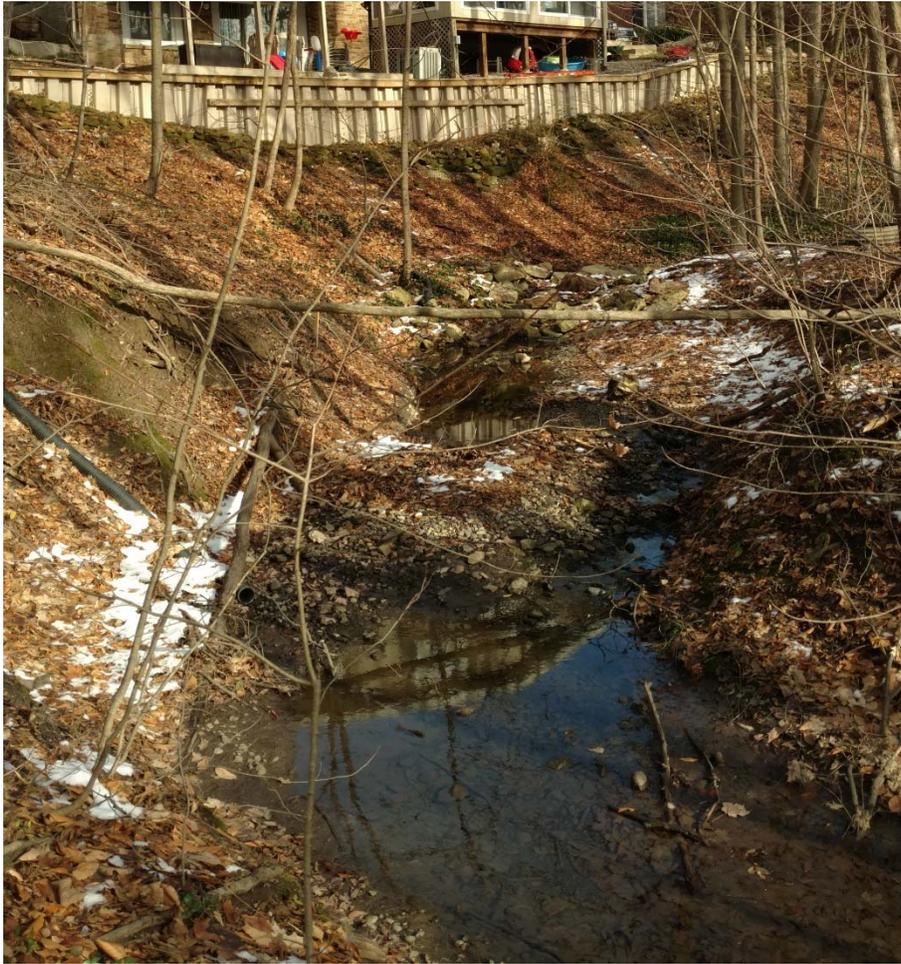
historically created the geomorphology of this watercourse since the natural contours in this area would have directed the drainage from the areas of Heathcliff Drive, Argus Drive and Grove Bluff Street to the north-south channel whereas this 21-inch sewer now concentrates all of this drainage into the east-west channel north of Golfridge Drive just east of the confluence between the E-W and N-S channels . The addition of this drainage area may have caused the watercourse to become unstable. In 2004, the City had constructed a series of rock or boulder check dams to reduce the erosive forces of the flow. While reviewing the plan, profile and dimensions of this stream it was observed that additional riffles are forming in between the check dams. This suggests that the slope of the channel has not been effectively controlled by the placement of the check dams. Additional check dams will not address the horizontal movement of the stream. Most storm generated runoff in developed urban areas is generally clean water. This means that the flow will not likely contain a sufficient quantity of sediment to naturally create the bankfull channel or stable flood plain in the progression evolutions presented in Table 1 above. A few riffle areas were observed to be developing shown in Figure 5.

Figure 5 – Where sediment is available, riffles have developed. Eventually, with enough erosion, bankfull features will become visible.

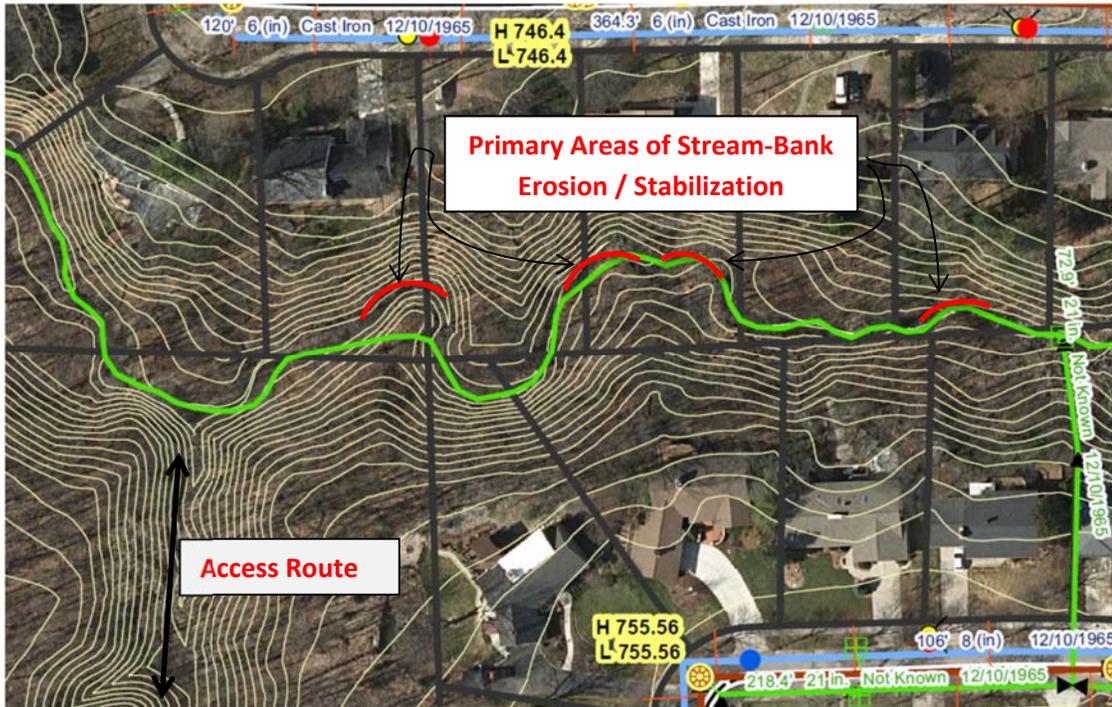
- If no action is taken at this time, we believe that the existing rate of streambank erosion in the areas shown in red on the right or north bank will continue its horizontal northward movement (see Figure 6). It was also noted that some of the residents have taken effective action to stabilize their specific properties. The placement of bank boulders is providing some stabilization. However we feel that the construction of these boulders has not properly been done to ensure a long-term solution and some adjustment is likely necessary.

Figure 6 - Proposed Area of Streambank Stabilization and Potential Access Route for a limited streambank stabilization project. Only the specific areas in red would be addressed.

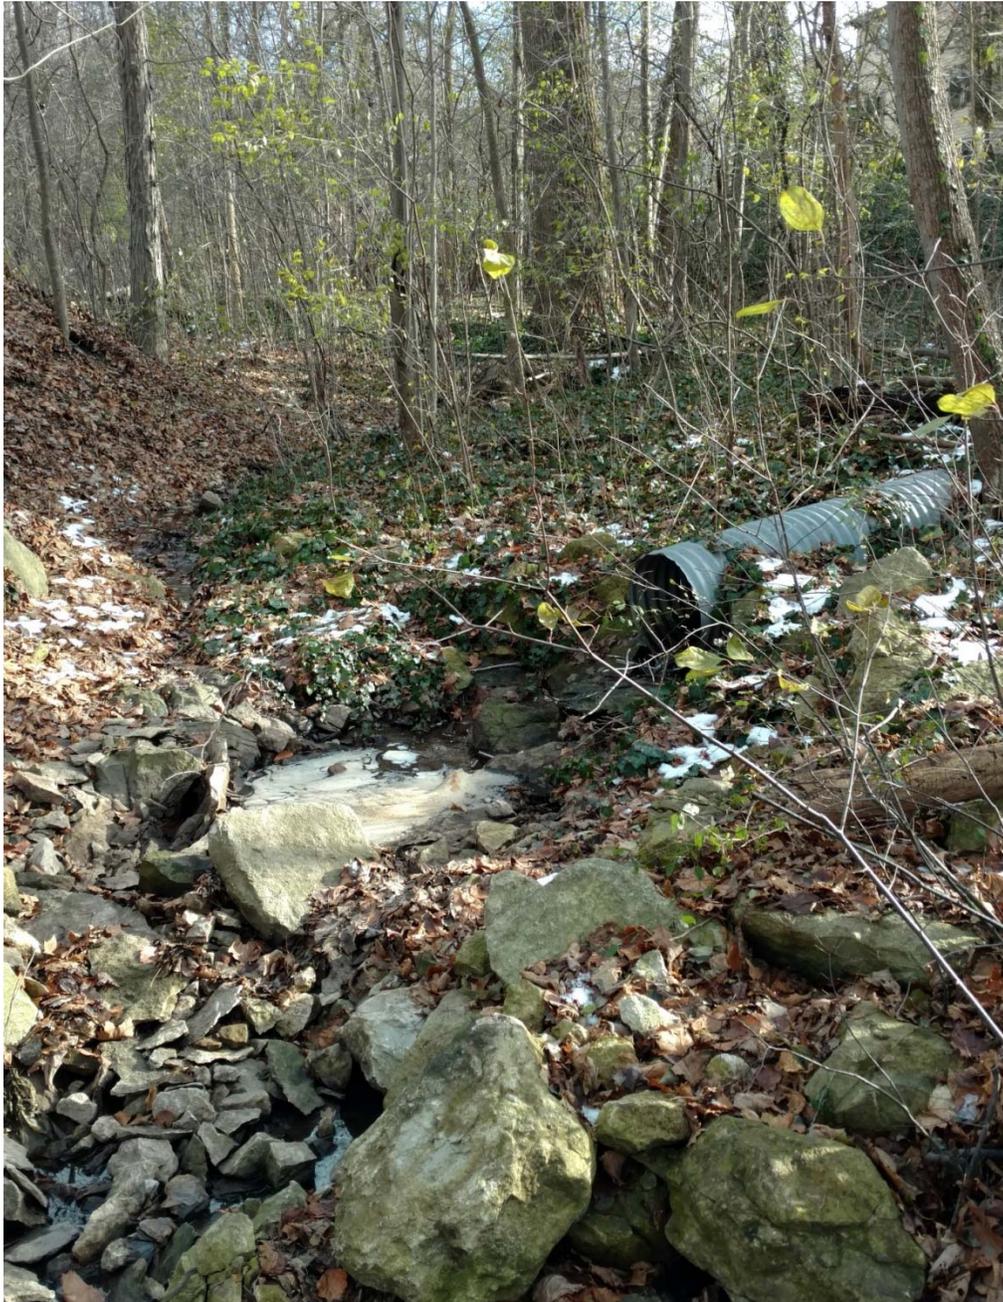
21-inch Corrugated Metal Culvert Structure Discharging from Golfridge Drive.

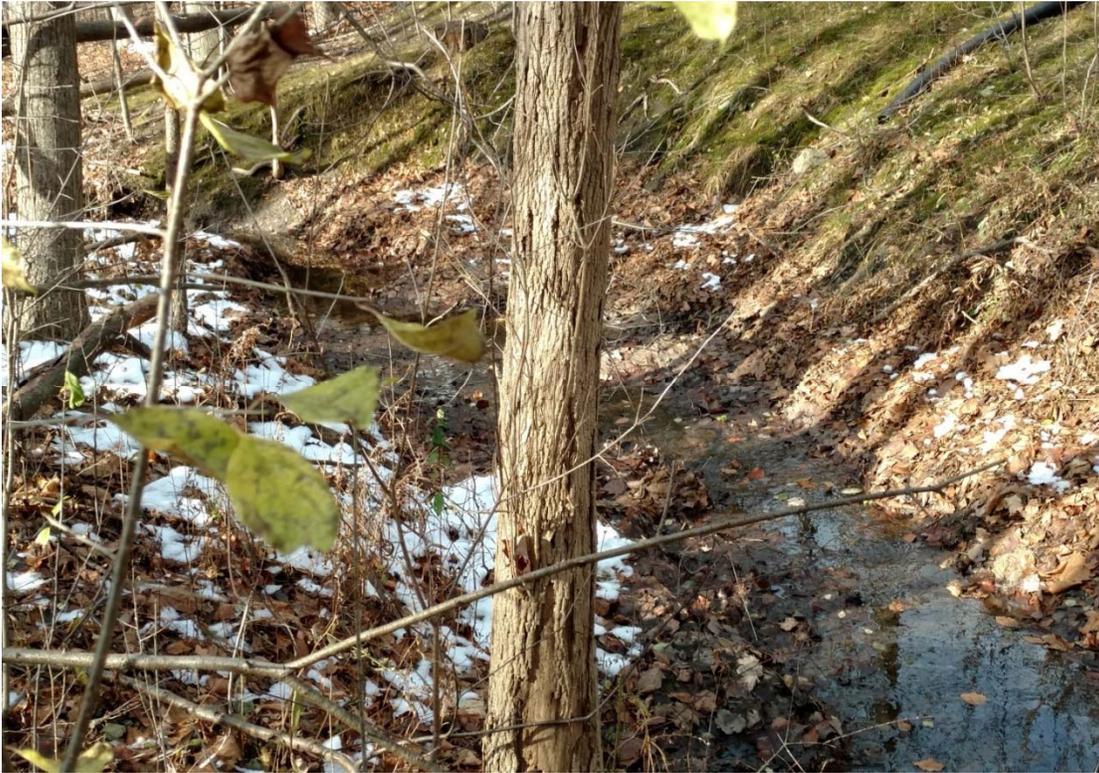
Stream channel immediately downstream of the 21-inch Culvert. The banks are relatively stable at this location.

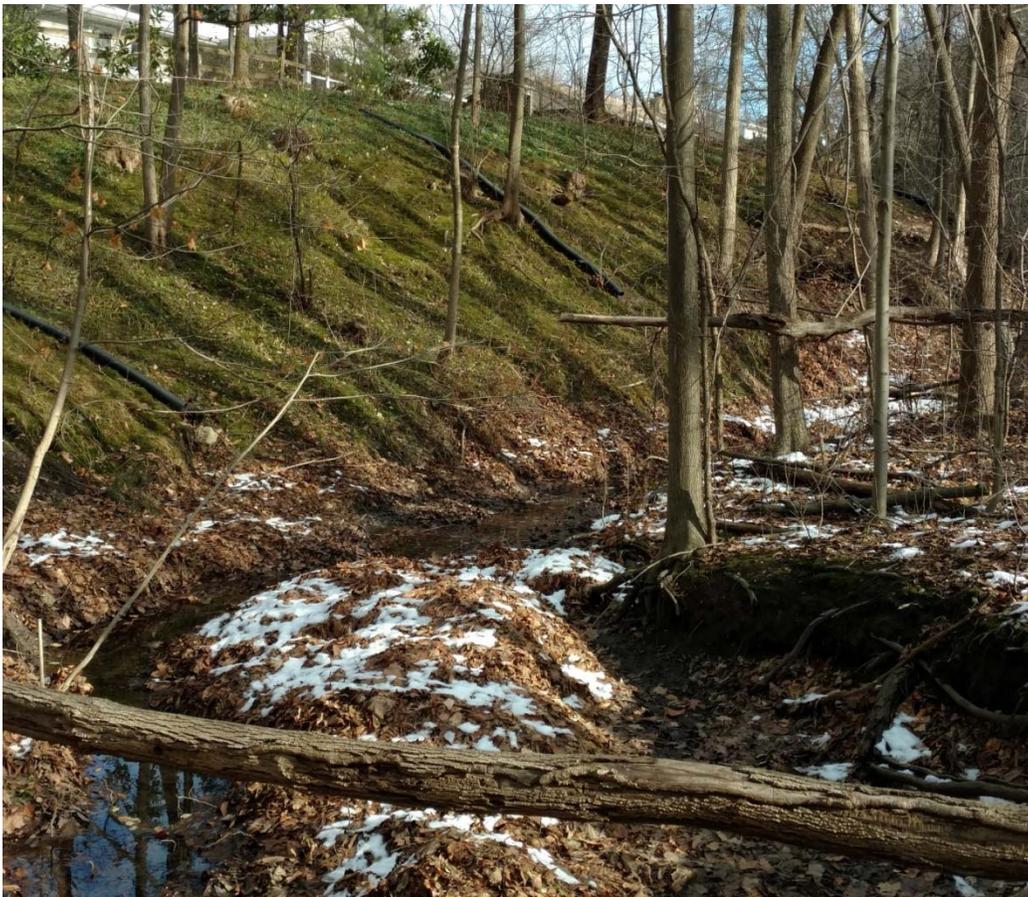
Stream Channel has split. Good location for a Bankfull shelf

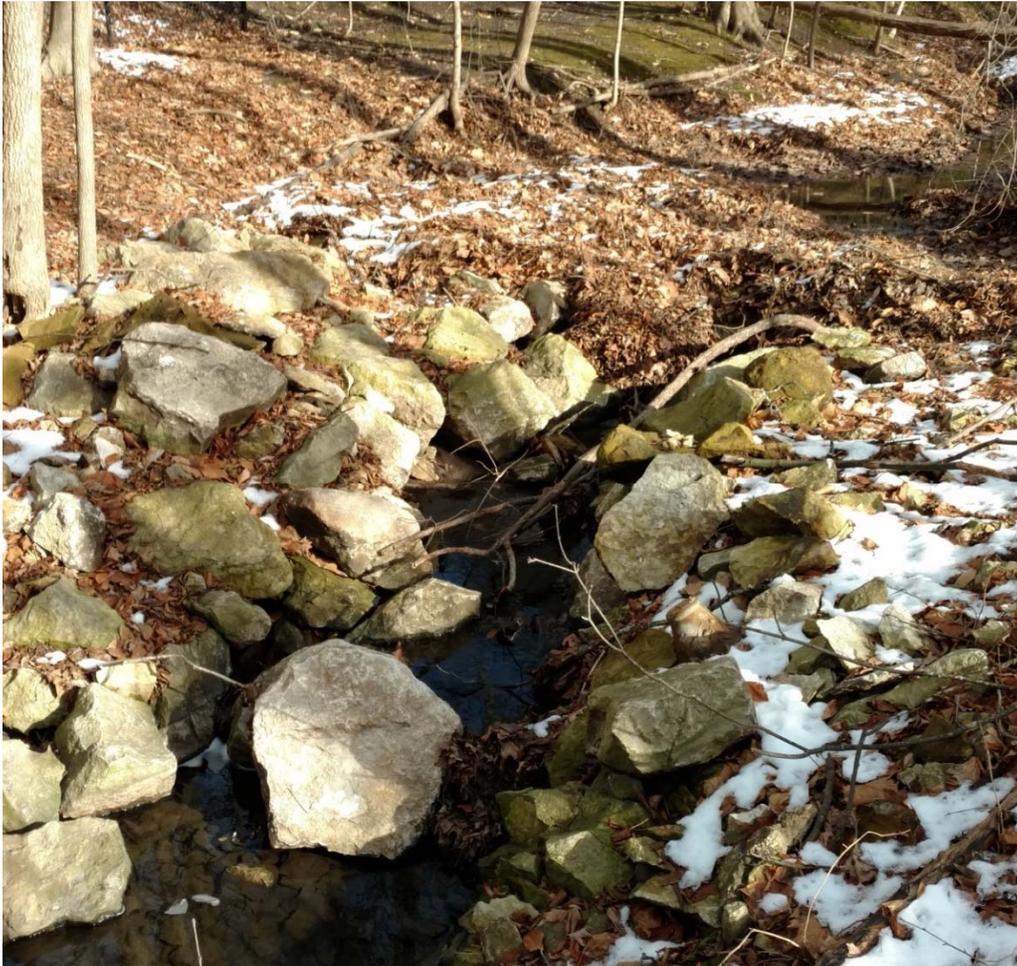
Most of the stream bed is composed of rock at this Check Dam. This location is effective and stable however excessive rock is present here can be used in other locations.

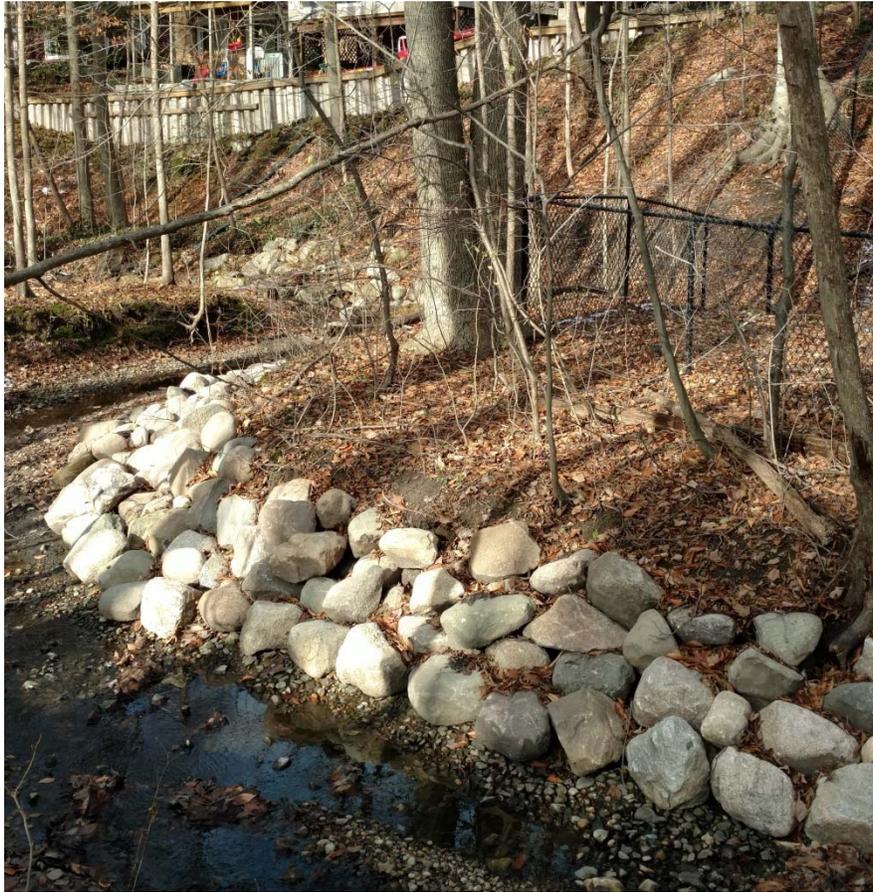
Bank protection installed by riparian property owner is effective however not very natural

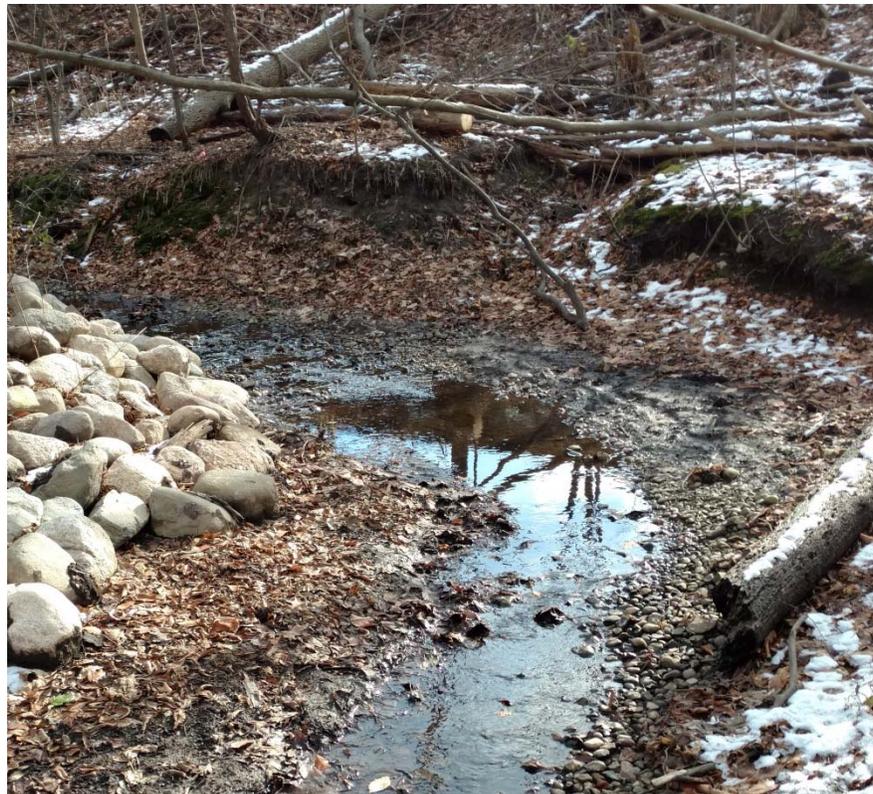
Erosion on the North or right bank is not significant and does not present any imminent problem to riparian property owners.

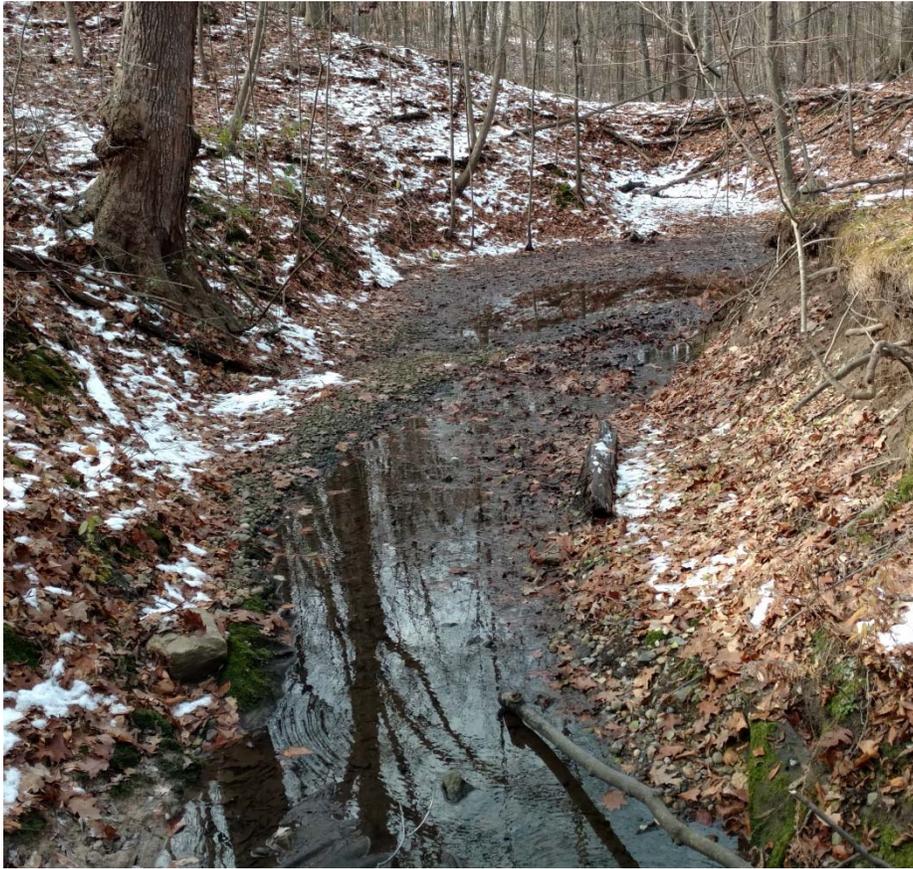
Over widened channel with no defined bankfull features. Riffle is forming in center of this section.

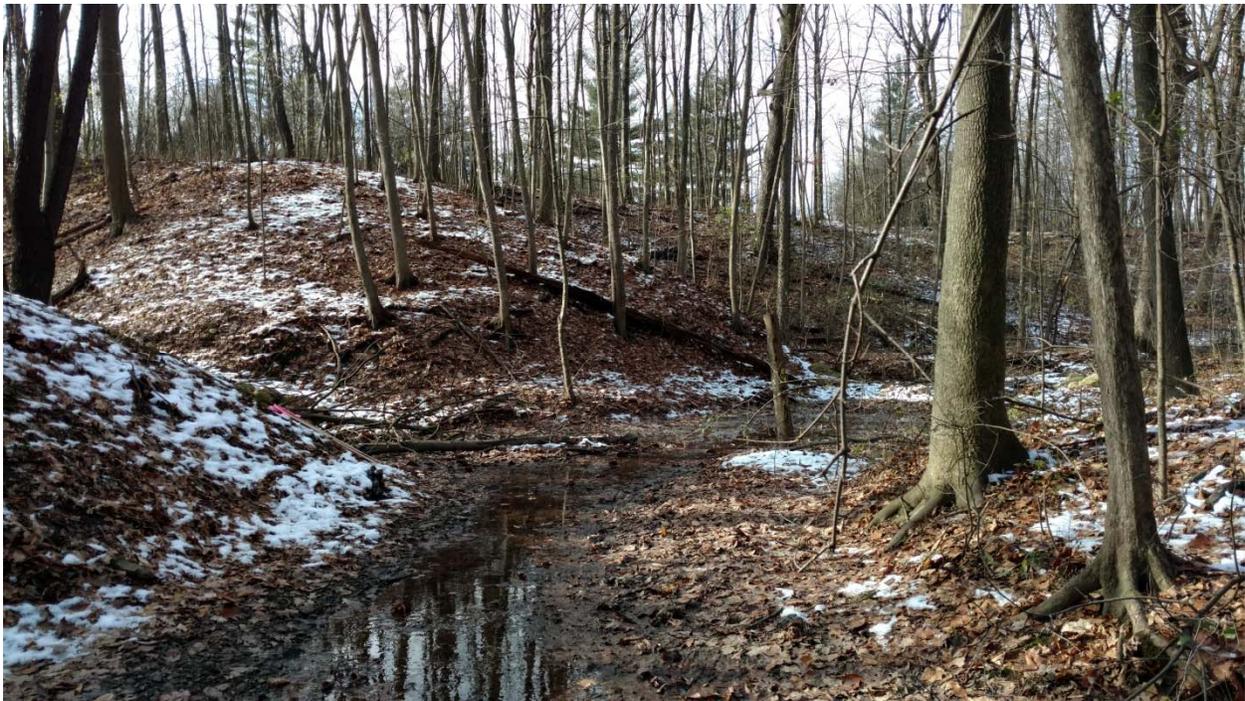
Confluence with the ravine from the south (behind Christ Church) (proposed as the access route).

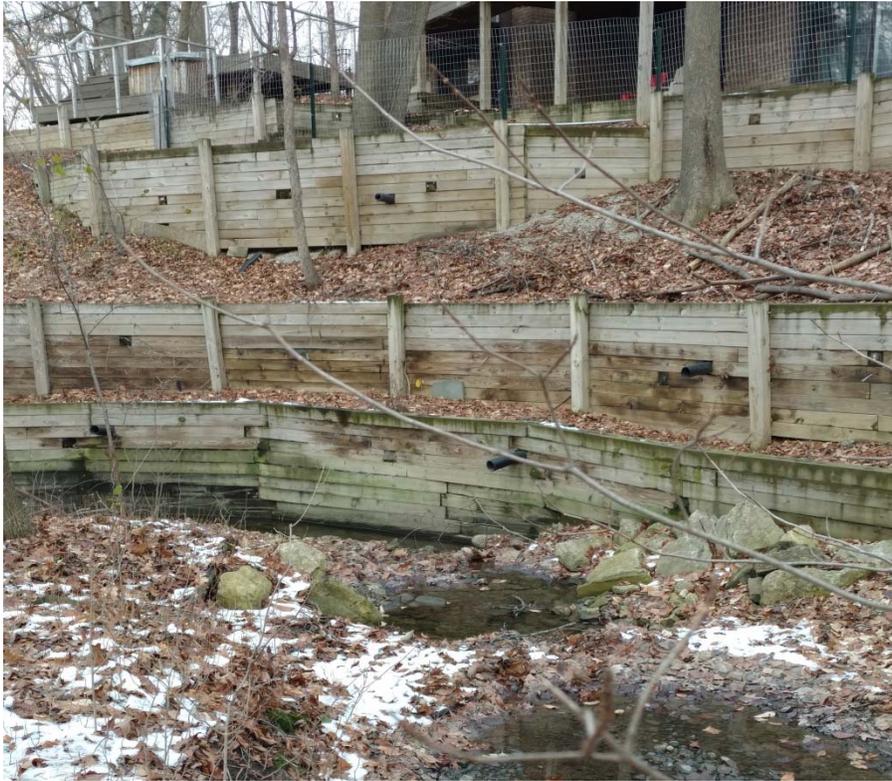
Terraced Timber wall Slope Stabilization by riparian property owner

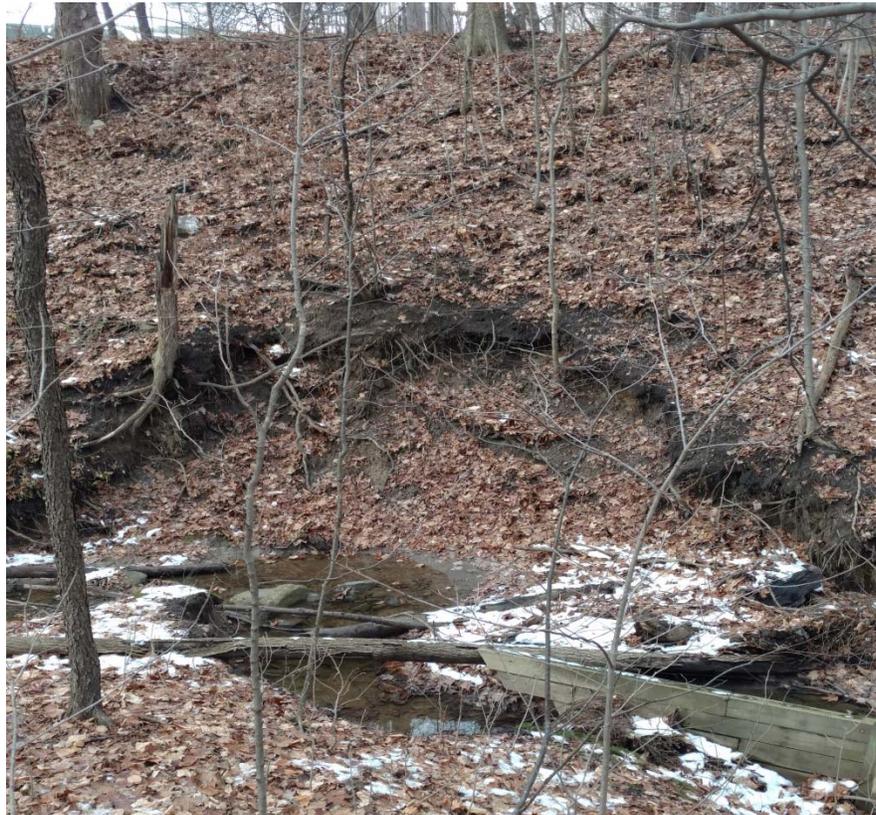
Highly eroded stream banks.
