Omena Avenue
Bank Stability Study

City of Grand Rapids

HUBBELL ROTH AND CLARK, INC

HRC Project No. 20160462

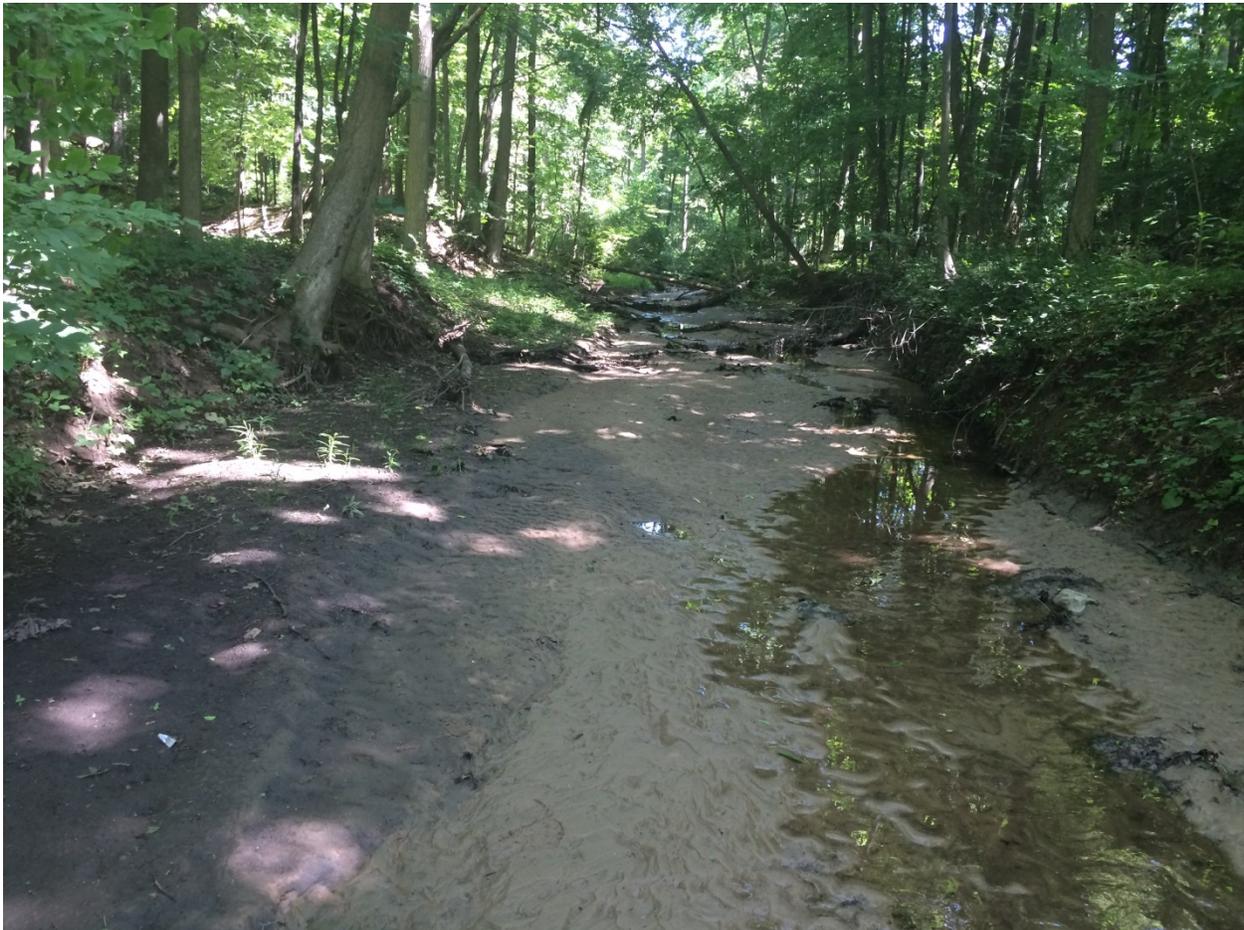
Figure 2 - Typical Drainage Channel

Figure 2 indicates what was typically observed throughout most of the study reach. The width of the active channel represented in Figure 2 measured out to be approximately 24 feet at bankfull. This suggests that the water forces and flow rates that created the channel were likely much greater at one time than what currently exists now and that water levels in the stream during discharge events are now not present and that channel slopes are steep enough so as not allow a bank full channel to form within the over widened existing channel.

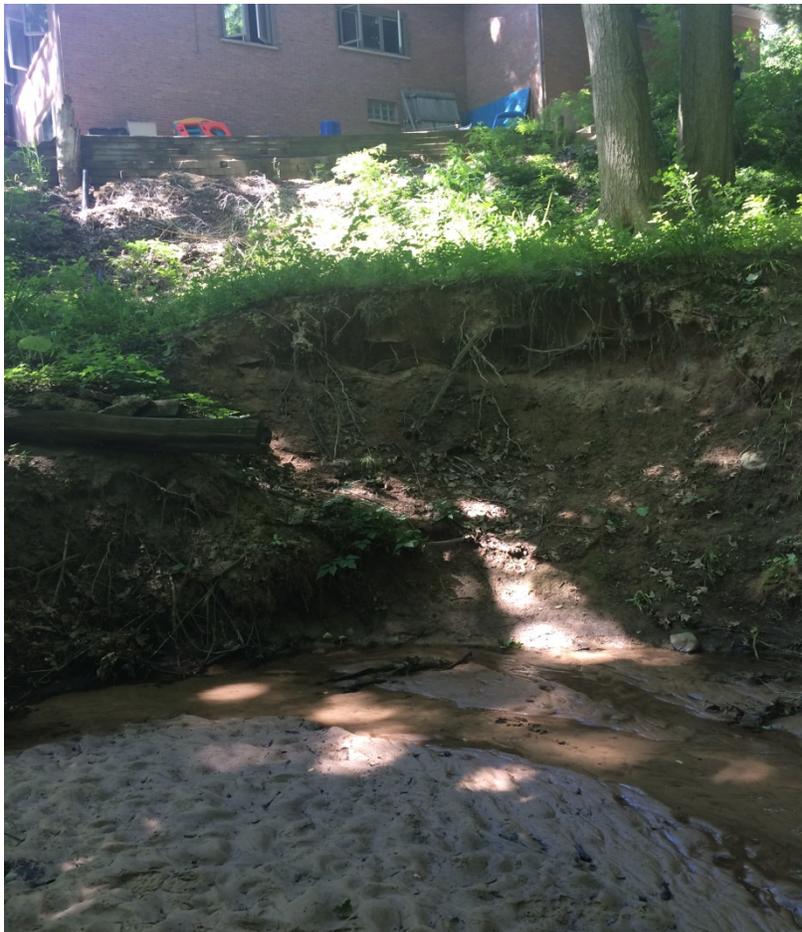
Figure 3 – Eroding Area near Eastward Channel Turn near South cul-de-sac of Shiawassee

- One home, at 2230 Shiawassee Drive SE, is near a sharp eastward bend and may be affected by bank erosion or failure due to stream bank erosion issues. Figure 3 is a picture of that location.

- **Costs.** The primary area of concern that can be addressed using the techniques described herein include the southwest bank of the eastward turn of the channel near the cul-de-sac adjacent to 2230 Shiawassee Drive SE. Due to the fact that the stream study reach is within a very steep valley, the logistics of accessing the eroded bed and bank areas will be difficult and costly. The techniques shown below would utilize local wood and boulders in the design. It is somewhat difficult to develop a solid cost estimate for this type of stream restoration, but based on using an assumed number of the bed stabilization techniques for the area described above plus adding in the difficulty of access, our opinion of project cost is approximately \$76,600 to accomplish erosion protection along this area of the stream. A breakdown of this opinion is included in the Table 2 below. The area being protected is as outlined in Figure 6, below. Full stream bed restoration along the entire stream reach included within this study is probably not warranted since the erosion that is occurring does not appear to be causing any imminent failures or immediately threatening the safety of existing structures.

- If no action is taken at this time, the existing rate of streambank erosion in the area of the eastward turn of the channel will continue. However it appears that it will likely take several years before the erosion will threaten any of the existing homes along the top of the banks. Assuming that the closest home to the south of the channel has a basement with a foundation elevation at least 6 feet below grade, the foundation elevation at the northeast corner of this home (Closest point to the channel) appears to be about 14 feet above the channel elevation and about 50 feet horizontal from base of the stream based on the REGIS topographic information. This resulting slope is only about 1V:3H which would not threaten the stability of the structure until the stream encroaches well further south. However, the stability of the land surface around the home may be threatened sooner since the average bluff slope at this location is about 1V:2.5H above the stream bottom. If the stream bank encroaches southward about 10 feet further, the stability of the land surface near the home might be threatened since the average slope would then approach 1V:2H and surface erosion from water flowing down the bluff slope as well streambank erosion might hasten the steepness. In any event the bluff slope would be hazardous and protective fencing might be necessary but this is inherent to a lot such as this with steep slopes.

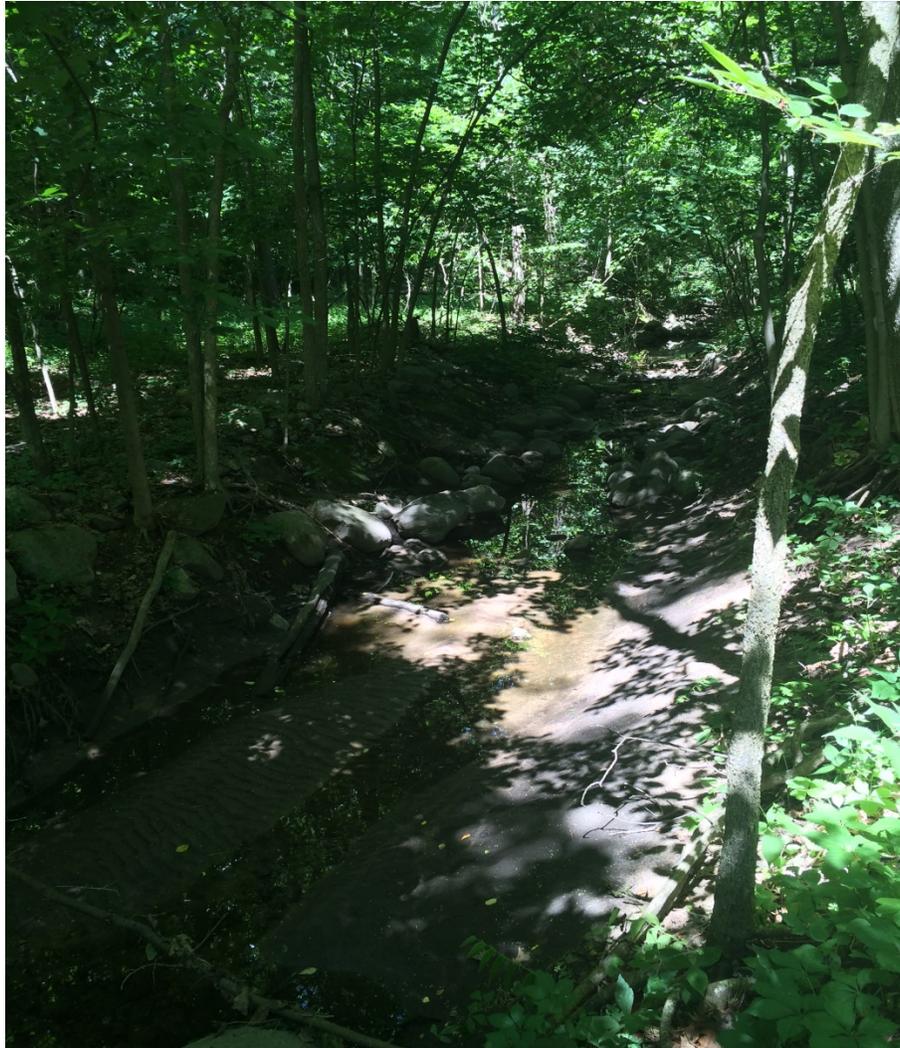
Figure 4 – Stream banks and bed stabilized by heavy boulder installation

After evaluating the entire length of the study area, there are few areas can be considered stable, with the exception of the areas hardened by boulders. The bank sections that were observed to be eroding are short in length and considered minor in that the sediment contributions from those reaches are very low. . The sediment within the bottom of the channel appears to be relatively immobile. Due to the age of the sediment and the fact that the channel is extremely over widened suggests that the stream does not have the hydraulic flow power necessary to transport the sediment which, if available, would form a much narrower baseflow bankfull channel. Boulders appear to have been placed in areas to reduce bank erosion as is shown on Figure 4 below.

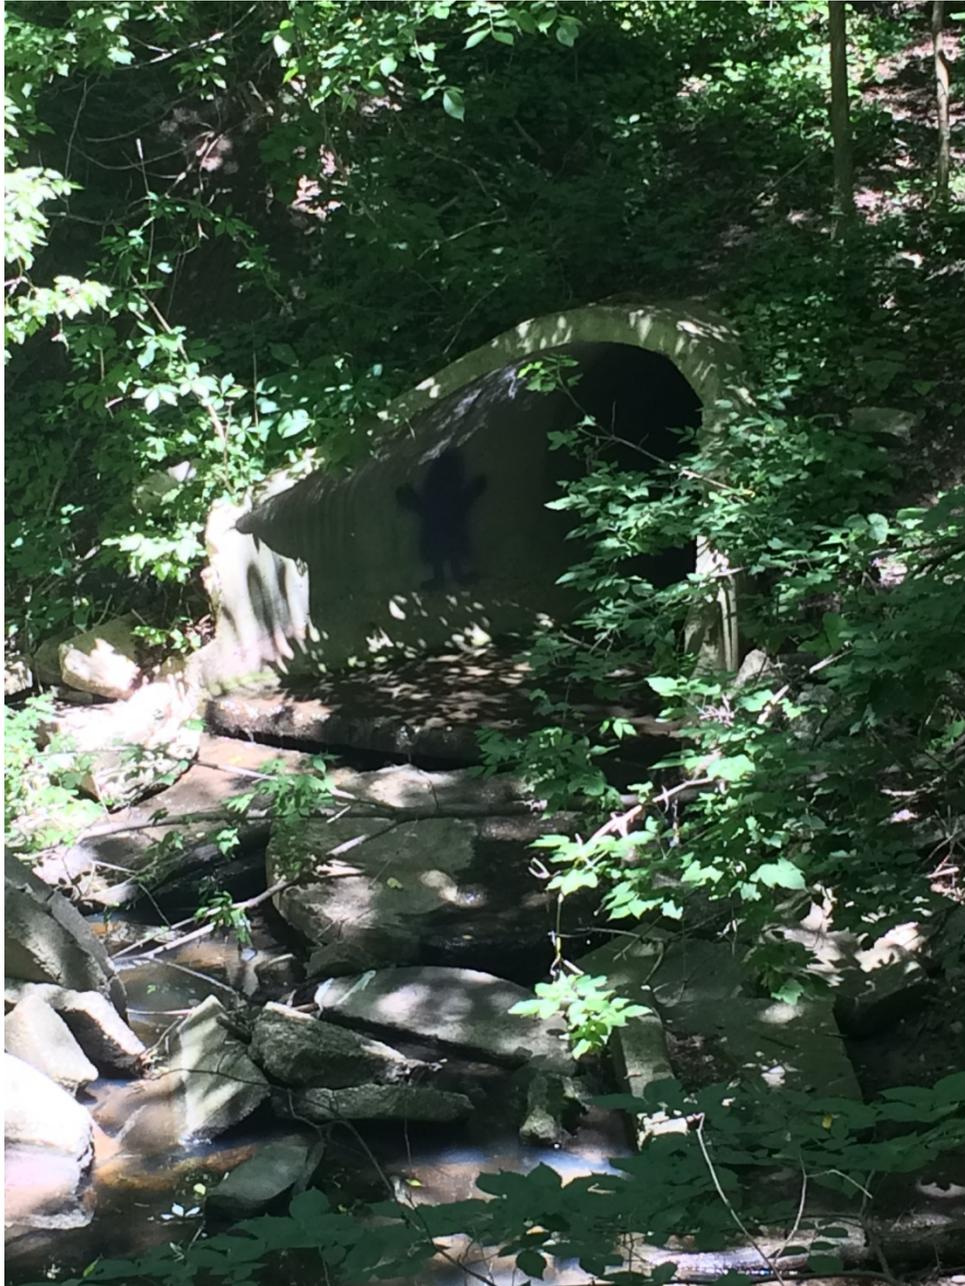
48-inch Concrete Culvert Structure downstream of Burton Street

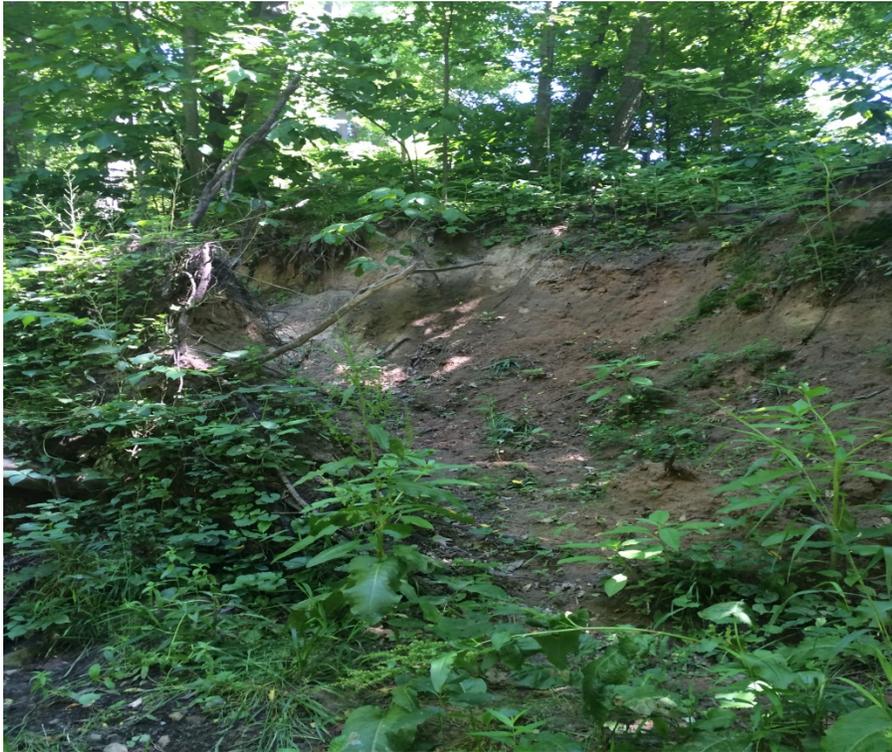
High Bank Erosion Immediately Downstream of Burton Street on the Bank

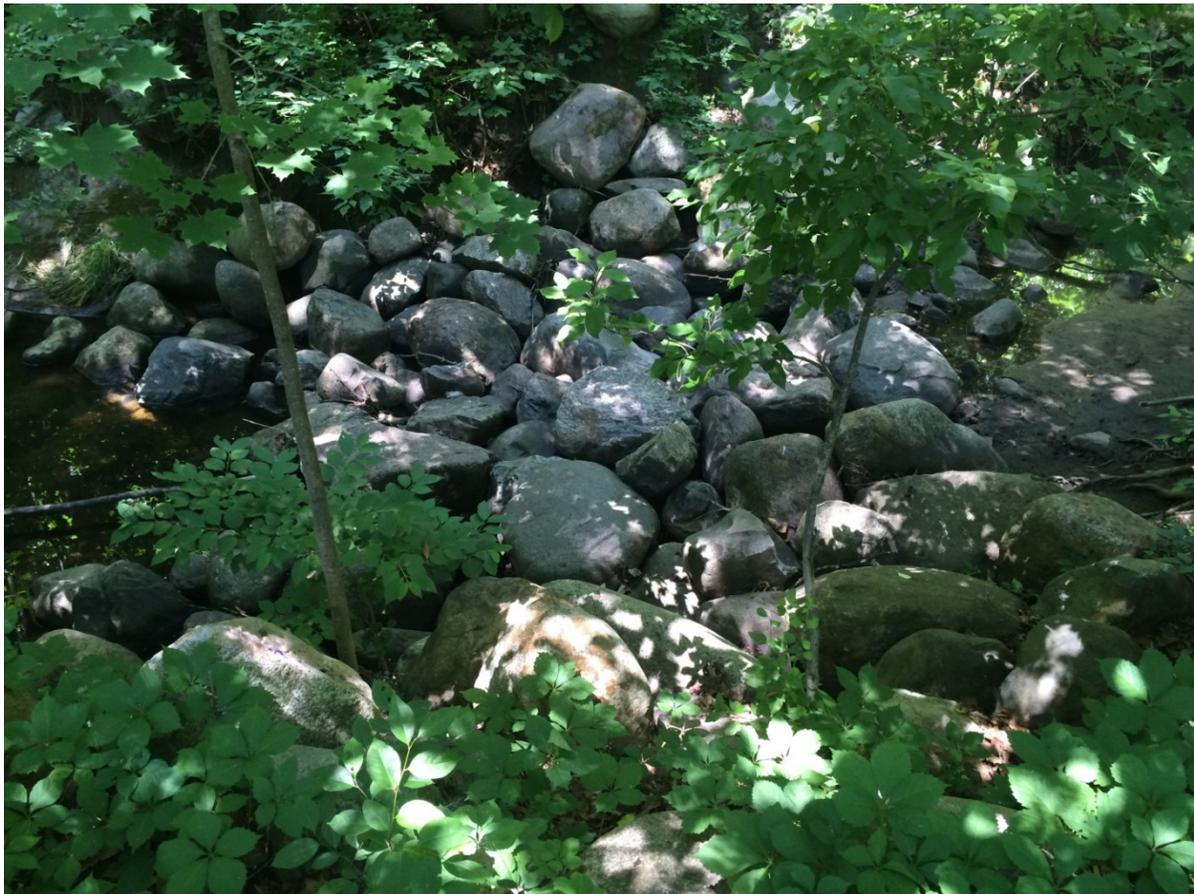
Bank Stability promoted with heavy boulders

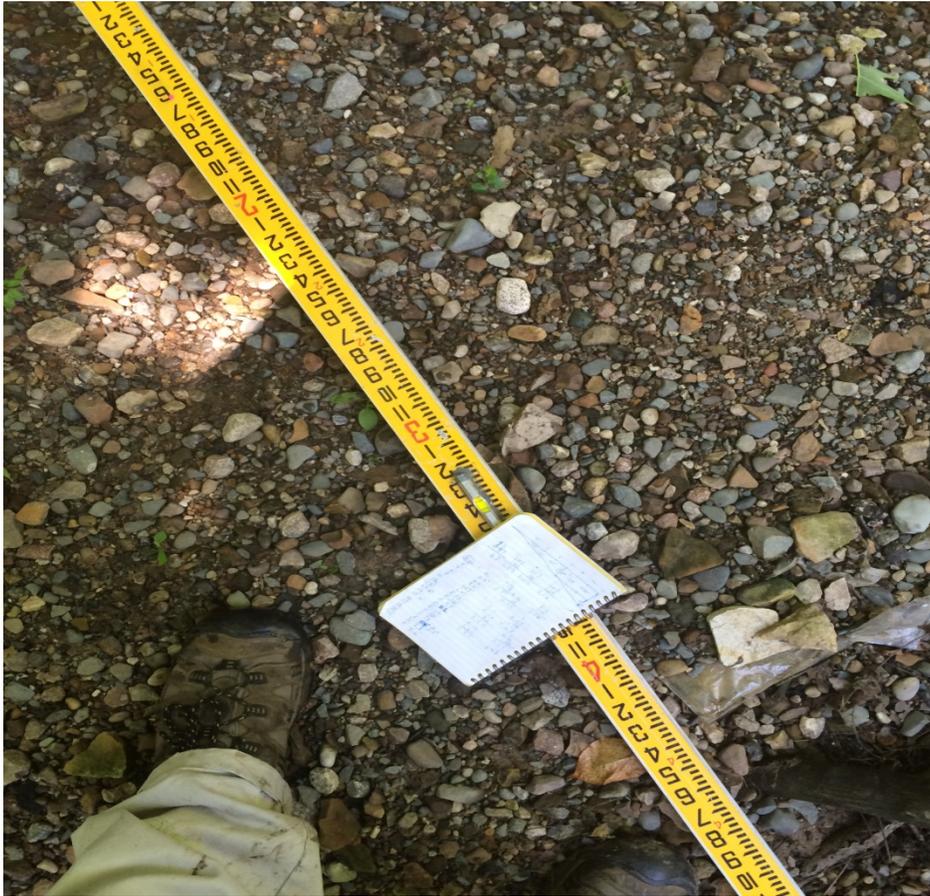
Most of the stream bed is composed of sand but one section was gravel.

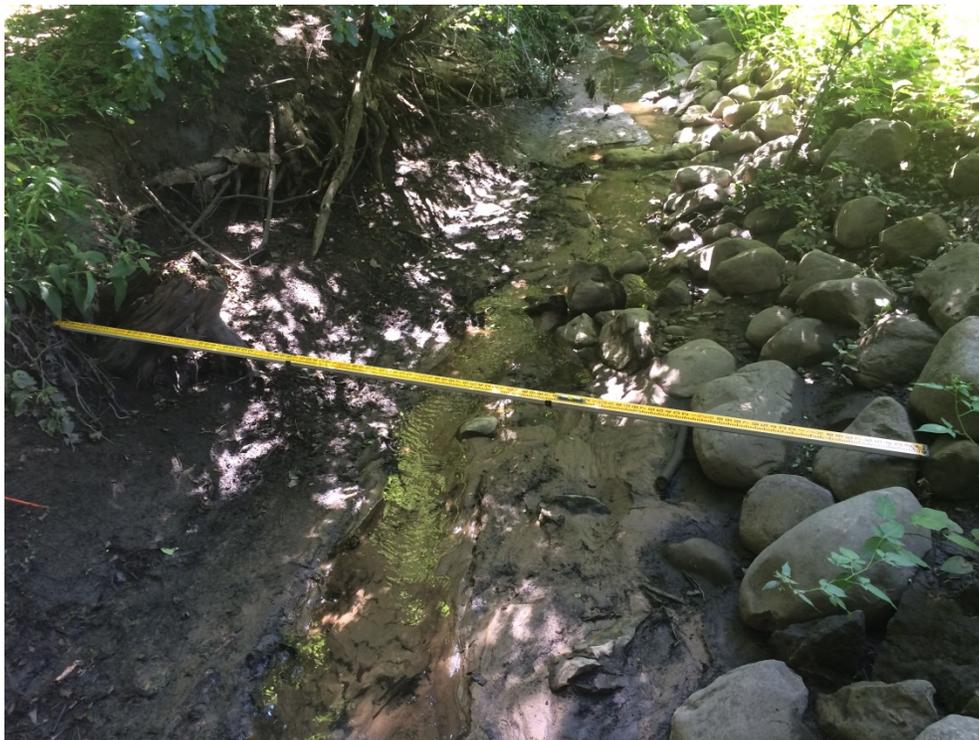
A small area of near reference bankfull width and depth

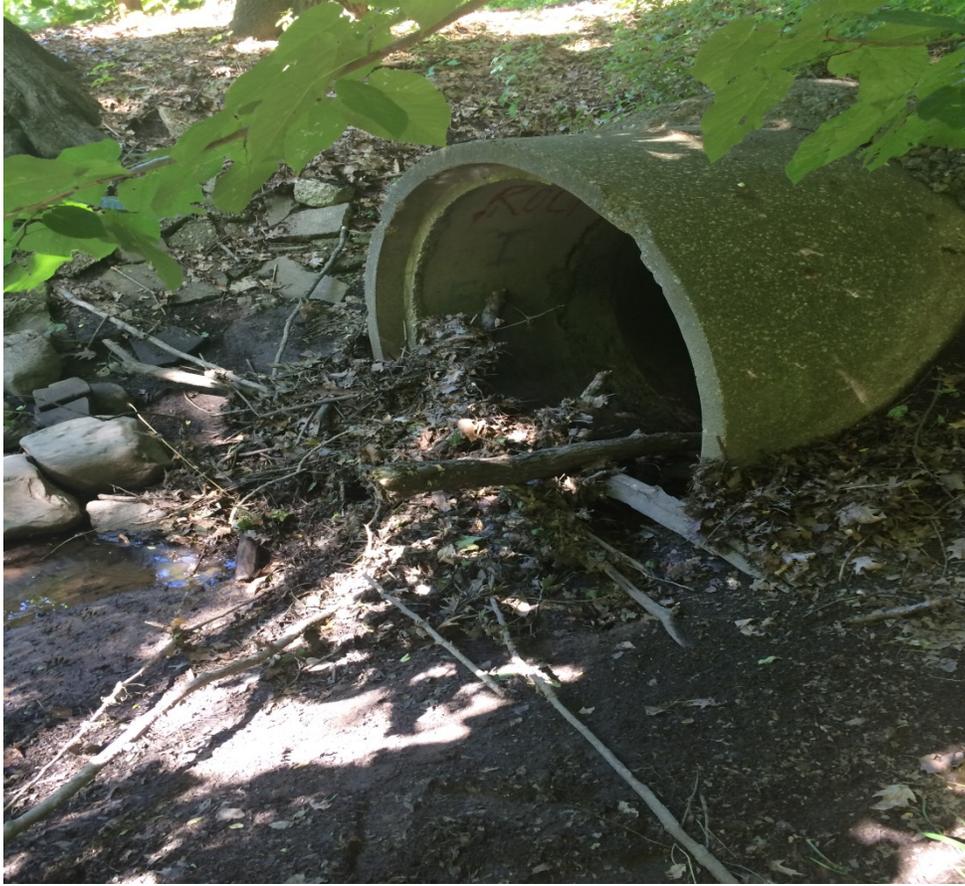
60-inch concrete culvert upstream of Shawnee Drive.
The small width and square edge entrance promotes debris to build up creating a small dam.
