City of Grand Rapids, MI

STORMWATER ASSET MANAGEMENT AND CAPITAL IMPROVEMENT PLAN

STORMWATER ASSET MANAGEMENT PLAN

City of Grand Rapids, MI
Environmental Protection Services Department
1300 Market Avenue
Grand Rapids, MI. 49503

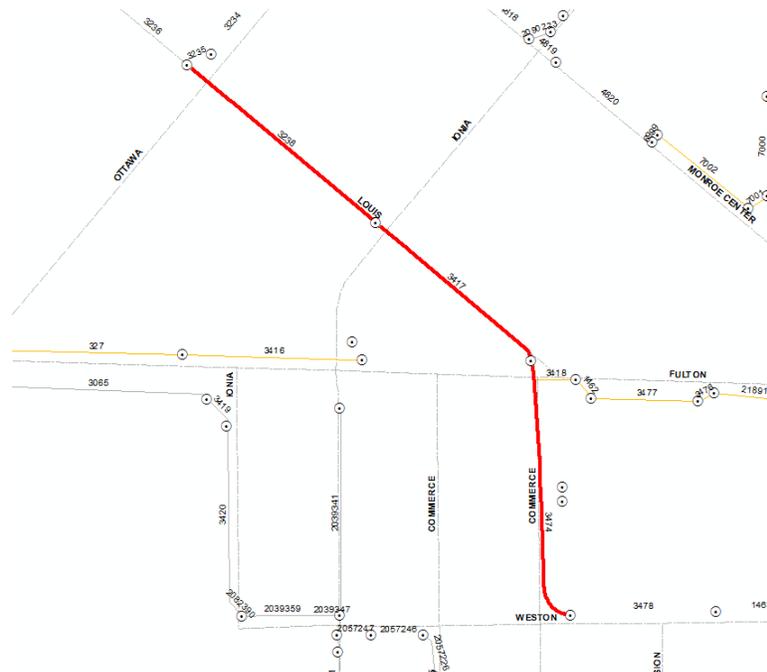
Figure 3-1 Example Louis Street Sewer Location (Asset ID 3238)

As an example of the data and analysis, consider the stormwater pipe on Louis Street NW between Ottawa Avenue and Fulton Street (Asset ID 3238), Figure 3-1. The pipe is a 72-inch box shaped brick sewer built in 1922. Refer to Figure 3-2 for the attributes, weights, and values used in this example. Three attributes were selected to determine the POF: the percent of useful life consumed, the maintenance condition, and the structural condition.

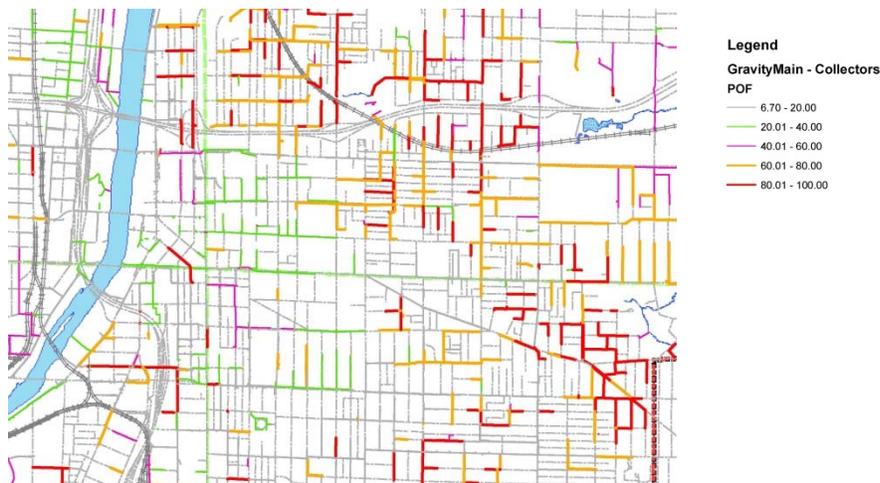
Figure 3-3 Probability of Failure Gravity Mains Example

Example figures of POF, COF and BRE for this example location are provided in Figure 3-3 thru Figure 3-5.

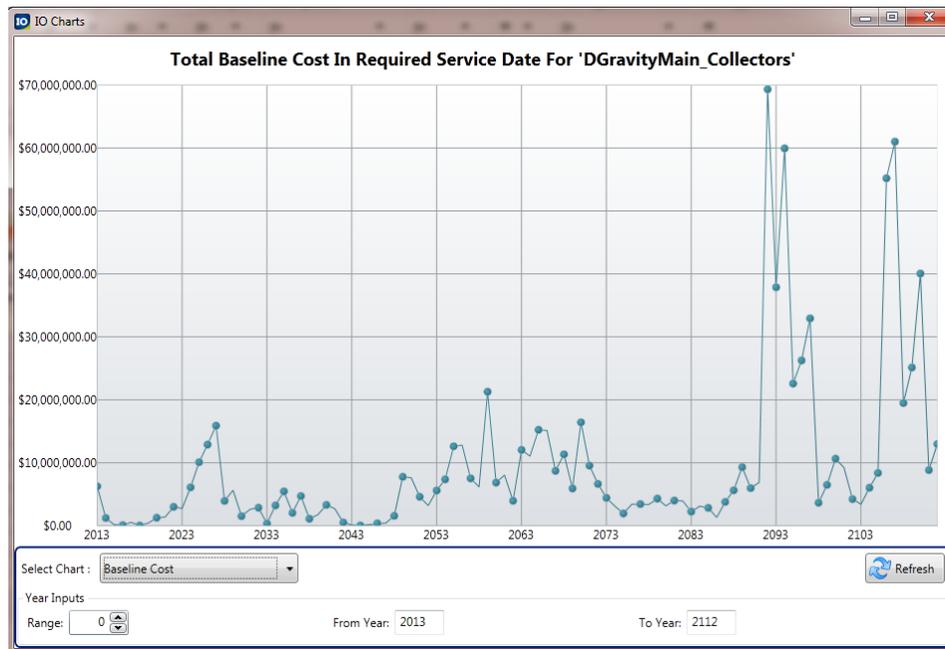
Figure 3-6 Annual Cost to Replace Gravity Mains at End of Estimated Effective Life

Figure 3-6 and Figure 3-7 illustrate the replacement costs per year based on the required service date for a 100-year timeframe. The baseline cost is based strictly on replacement costs, though in many cases pipes will only require rehabilitation or no action at all. The high annual replacement costs observed between 2090 and 2110 are a result of the recent sewer separation program associated with the CSO program.

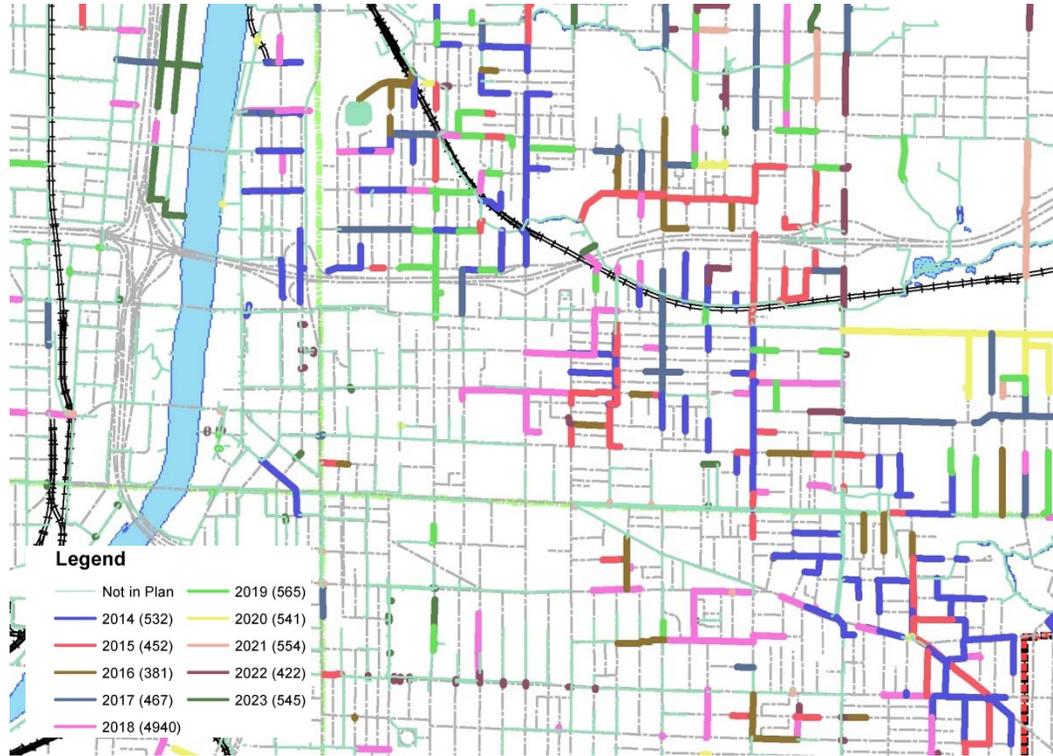
Figure 6-1 Assessment Strategy Example Map

\$212,000. The assets requiring evaluation were prioritized and distributed over the proposed ten year program schedule. The results of prioritizing the assessment of the gravity mains are provided on system maps in Appendix B. An excerpt of these maps is shown in Figure 6-1 to illustrate the level of detail provided.
